MARYLAND COMPREHENSIVE HISTORIC PRESERVATION PLAN DATA - HISTORIC CONTEXT

The Maier House -- Building 531

Beltsville Agricultural Research Center -- Beltsville, MD

Maryland Historical Trust Inventory Form
Maryland Comprehensive Historic Preservation Plan Data
The Maier House -- Building 531 -- MHT # P.G.: 64-10
Beltsville Agricultural Research Center
Prince George's County, Maryland

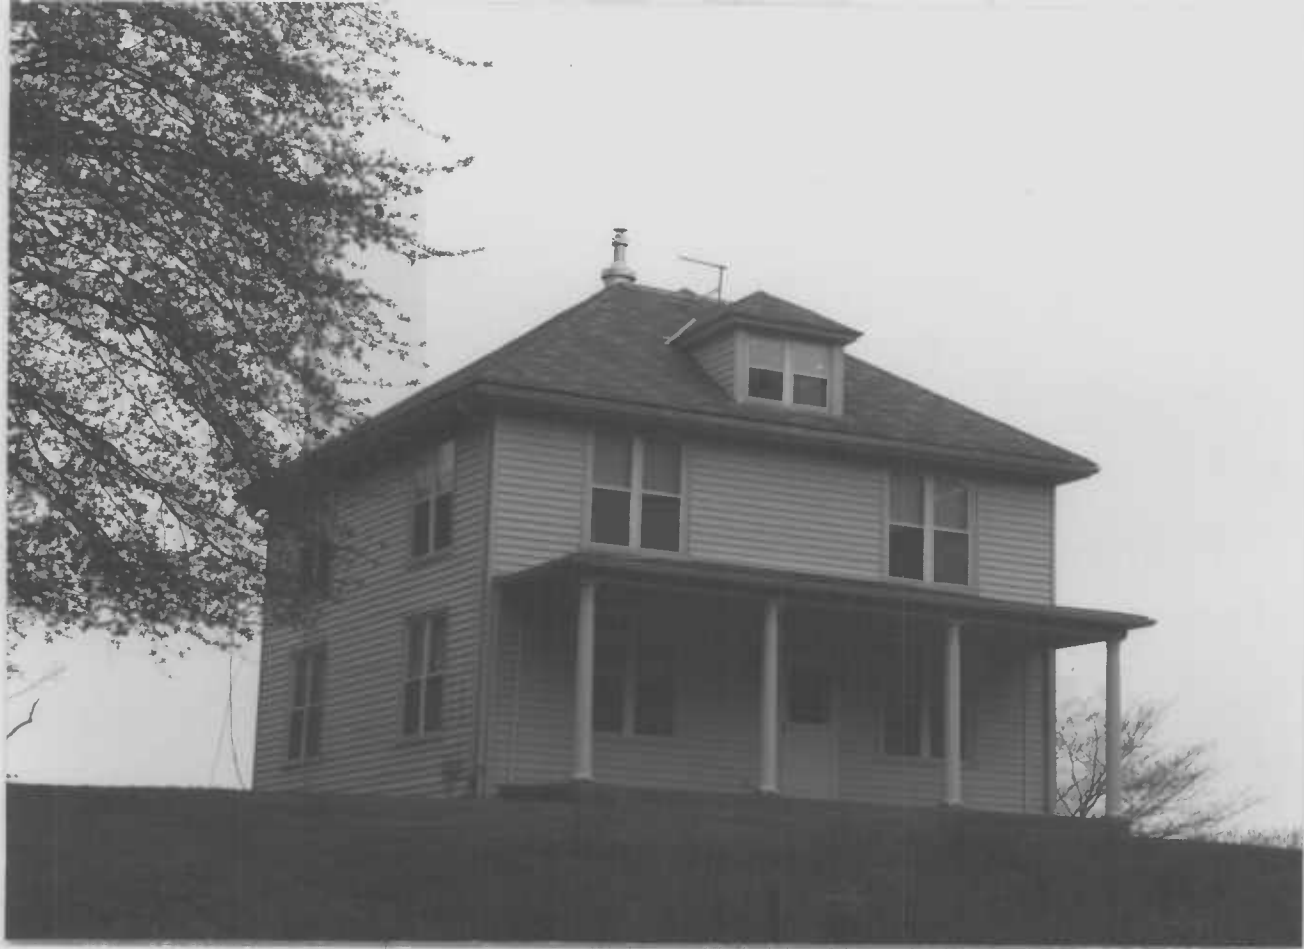
WEST FACADE, LOOKING EAST

The primary facade, which faces west, is three bays wide and features an entrance placed slightly off-center in the center bay. It consists of a small wooden door, with an exterior metal screen door. A one-story porch runs the width of this facade. Supported by four simple wood columns, the porch has a very gently sloping hipped roof. On the first story, in the outer bays, paired windows frame the central door. Likewise on the second floor, there is a paired window set in each outer bay, with no window in the center bay over the entrance door. Centered on the roofline is a projecting dormer with a pyramidal roof and paired one-over-one windows.

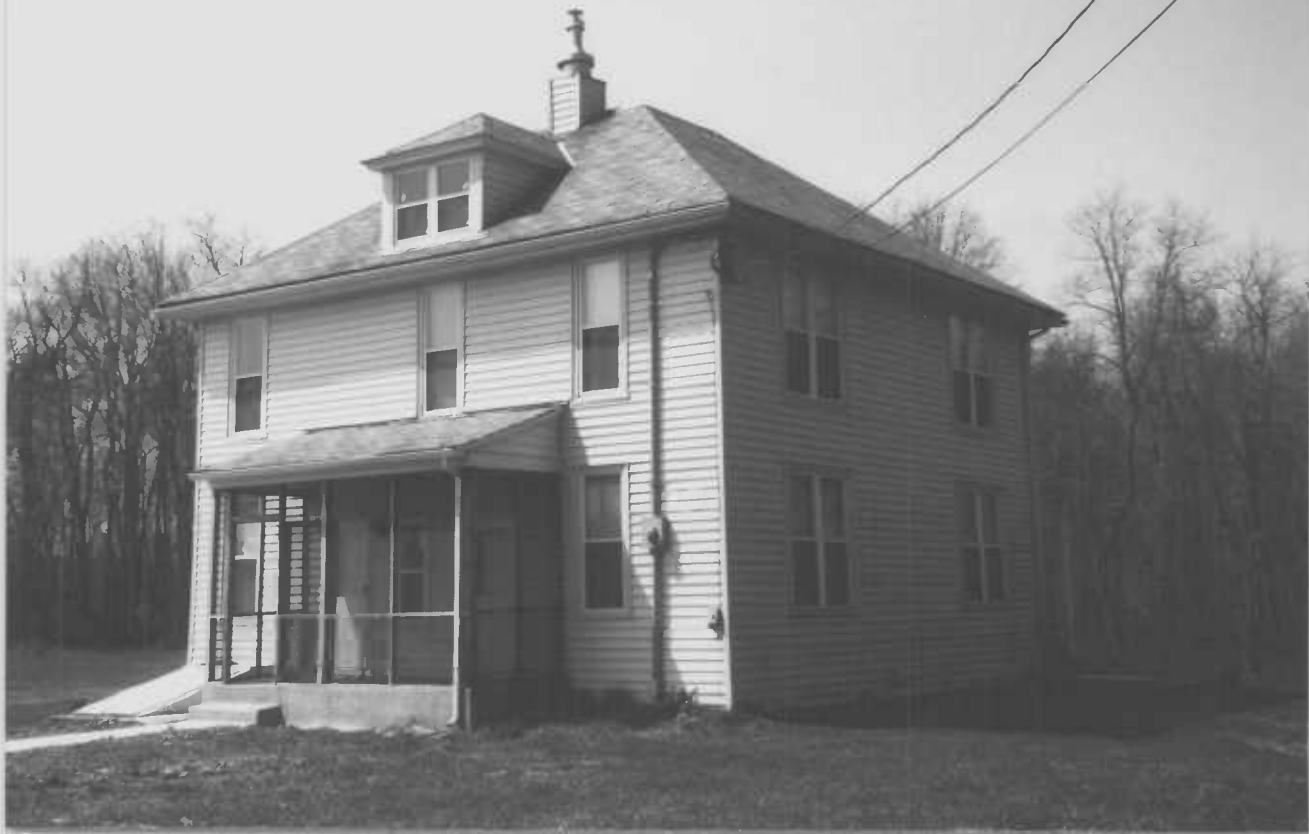
EAST + NORTH FAZADES, LOOKING SOUTHWEST

The north and south facades feature two paired window sets on each floor. The south facade features in the westernmost bay a paired window on each floor. In the center bay, there is a paired window in the second floor and a tiny box-like one-over-one window at the first floor level. The easternmost bay features a single, tall, narrow one-over-one window at the second floor, and a shorter one-over-one at the first floor.

The rear (or east) facade, which today provides primary access to the house, has two entrance doors in the central bay. Both are enclosed by a shed-roof screened porch, which sits on a raised concrete block. Between the two doors is a narrow one-over-one window. This facade, unlike the principal facade, does not have paired windows. In the outer bays, outside the screen porch, is a one-over-one window. The second floor features a single one-over-one window in each of the elevation's three bays. The center window appears slightly off center. In the center of the roofline is a projecting pyramidal-roofed dormer, with a paired one-over-one window, identical to the dormer of the west facade. At ground level, to the south of the porch, is located the entrance to the basement.

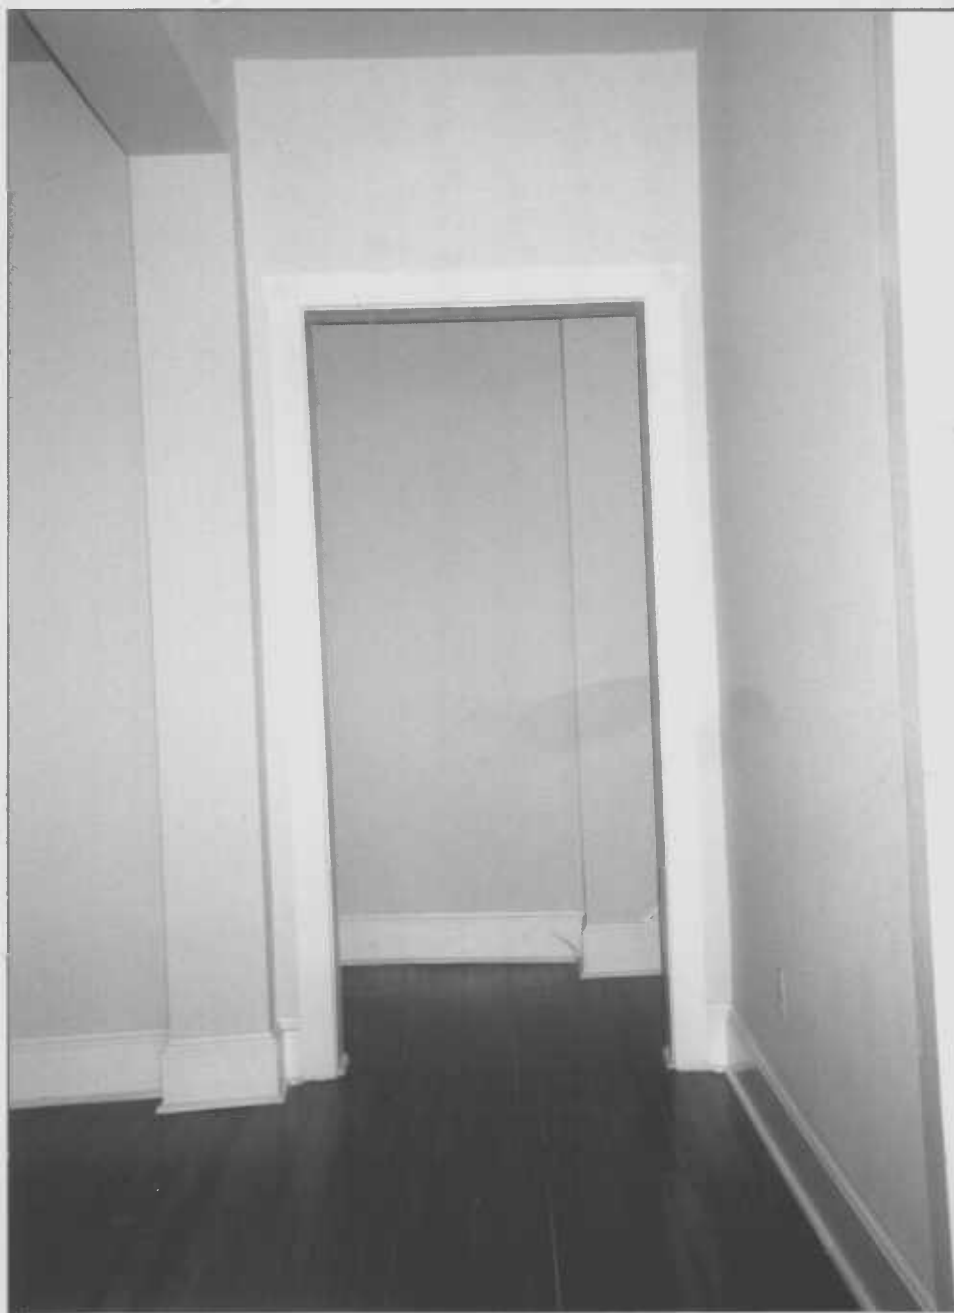
INTERIOR, FRONT HALL, LOOKING EAST

The front door opens onto a large living room, the windows and doors of which are distinguished by corner block molding with paterae. The living room occupies the northwest corner of the house. In plans drawn up by the U.S. Department of Agriculture in 1938 after its acquisition of the house, the front door opened onto a central hall, that ran between the living room and the spare room in the southwest corner.² Part of the alterations undertaken by the government included the installation of a small bathroom, located under the stairs in this spare room. The dining room, located in the northeast corner, is not separated from the living room by a full wall, but rather by a large central opening. The area at the rear of the house in line with the central hall contains the pantry; it is framed on either side by the rear entrance doors, one of which opens onto the dining room, the other of which opens onto the kitchen. The kitchen, in the southeast corner of the house, also contains the stairs to the basement.
